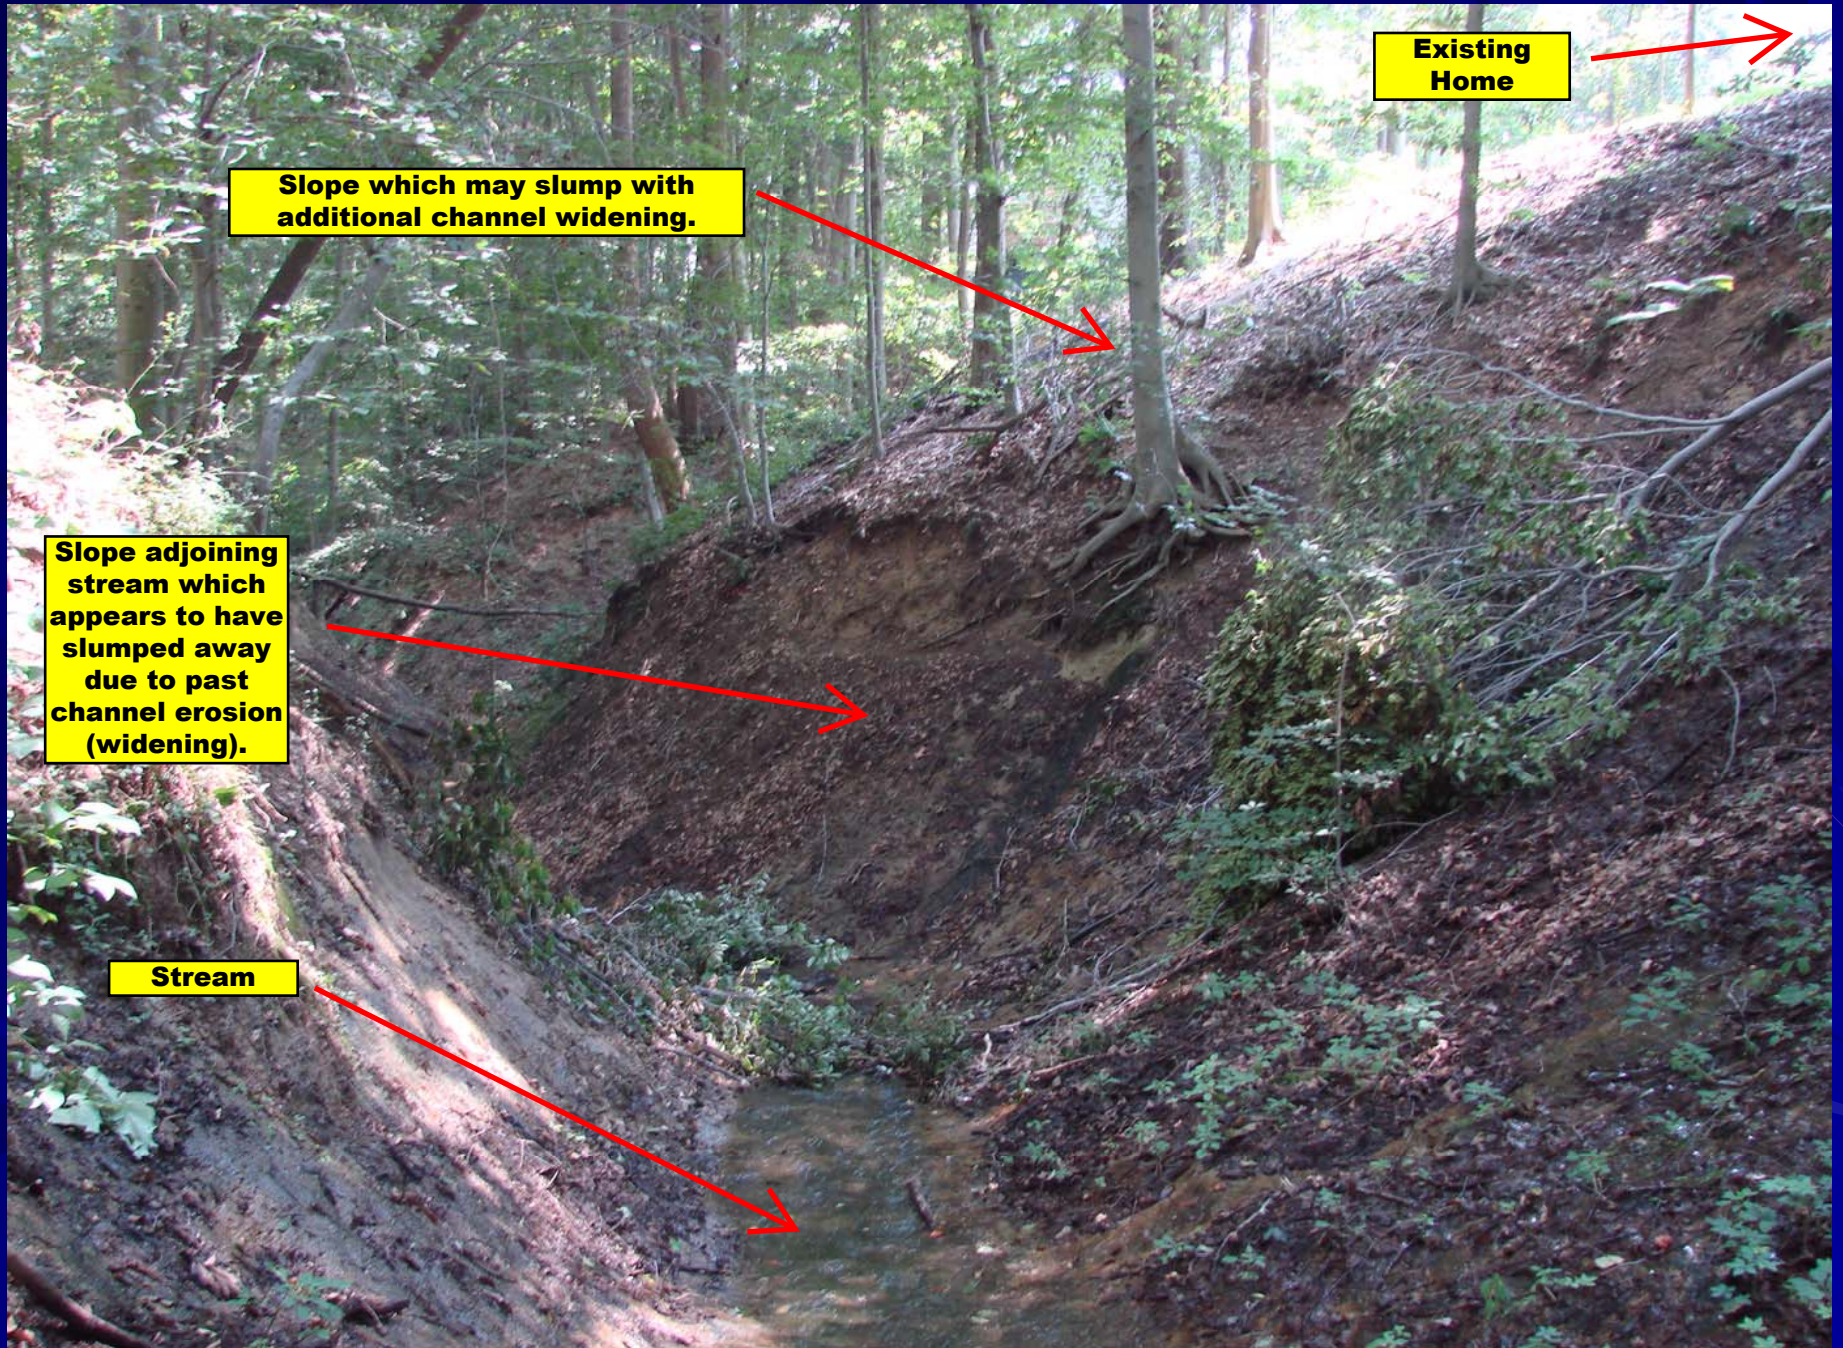
Slope which may slump with additional channel widening.

Slope adjoining stream which appears to have slumped away due to past channel erosion (widening).
